Brook Walk Fall 2023 Report

October 6, 2023

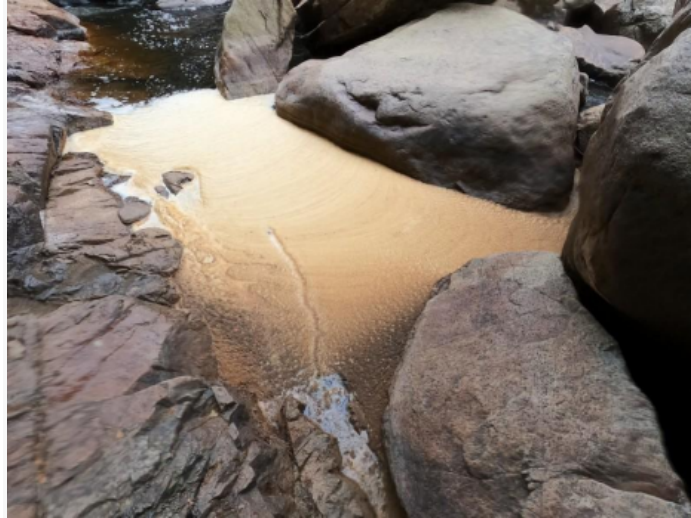
Natural foam on the Ausable River.

Naturally occurring stream foam can be off-white, light tan, or brownish and can have a fishy or earthy odor. It's formed by dissolved organic matter, usually dissolved organic carbon (DOC). DOC results from the breakdown of organic debris, such as sticks, leaves, and tannins and watershed soils that hold organic materials. One way to describe organic matter is to compare it to a tea bag. The earth and its soils are rich in organic materials from the breakdown of plants and animals and as water moves through the soils of a watershed it collects the organic matter and then darkens just like a cup of hot tea. Once in a stream, the color largely dissipates but can tint the foam it produces.

In a stream, DOC acts as a surfactant reducing the surface tension of water – a common example of a surfactant is olive oil. DOC interacting with the moving water causes tiny air bubbles to form, creating an area of lower surface tension so water subsequently flows away from that spot and foam can stabilize there. Natural foam build-up is more prevalent in streams and rivers after rainfall because there's more water moving through the ground and more organic matter being dissolved. With higher water, more turbulent conditions form bubbles, and the DOC attaches to these forming foam at the surface.

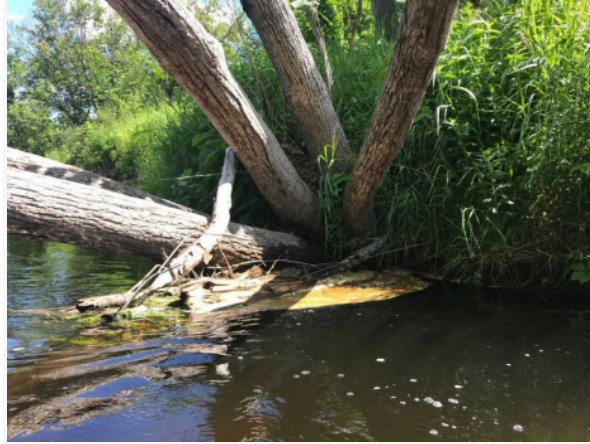
Organic rich foam trapped by a tree and natural debris on the East Branch of the Ausable River. To minimize human-made foam, reduce the use of synthetic chemicals on outdoor surfaces and, where you do use them, follow label instructions carefully. Also, make sure your septic system is properly maintained. Most residents of the Ausable watershed rely on private septic systems. Wastewater leaving your house from the shower, toilet, sink, clothes washer, and dishwasher all enter your septic system, carrying chemicals, solids, grease, dirt, and pathogens. A properly designed and maintained septic system treats and disposes of this wastewater, preventing contaminants from entering our natural waterways. - *Leanna Thalmann, Water Quality Associate*

While most foam is naturally occurring, it can also be human-made. Synthetic or human-made foam is usually a by-product of chemical runoff or industrial discharge. Sources include household cleaning products that contain synthetic surfactants, house paint, pesticides used on lawns or fields, or motor oils running off impervious surfaces. These chemicals – small repeating amounts over time or large pulses – can disrupt the aquatic ecosystem and undermine its balance. Human-made foam tends to smell fragrant (from detergent discharge) or unpleasant (the product of septic failures). Although you should never touch it, human-made foam is sticky and usually a pure white color but may turn darker as debris particles filter through. It will often be found near the point of discharge.
